2018年2月 永瀬ダム 自動濁度装置 測定結果一覧表

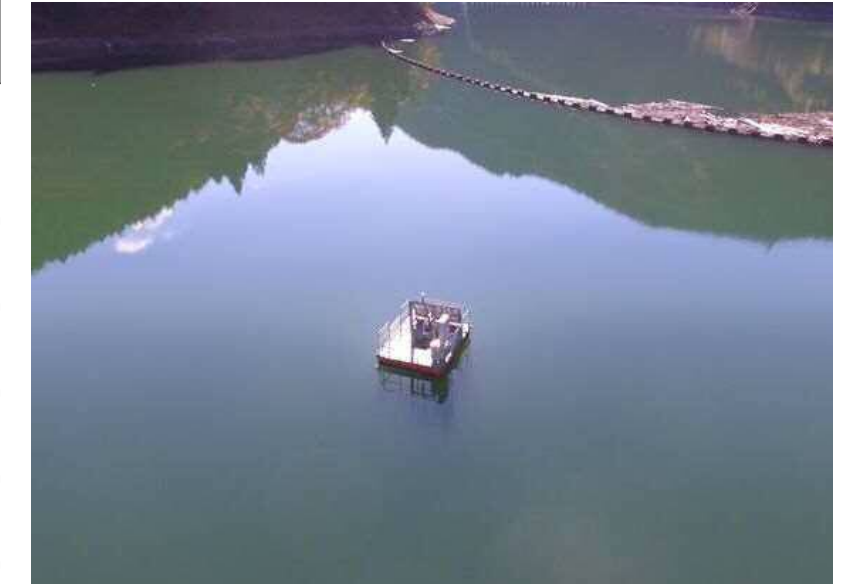
▲自動濁度計 全景

永瀬ダム堰堤上流付近に台船を浮かべ、その上に自動で濁度を取得する装置を設置しています。
 毎日朝9時になると、測定器を沈め、それぞれの深度における濁度を計測しています。
